Impalpable İmplanon Palpe Edilemeyen İmplanon

Elif Gözdemir¹, İkbal Kaygusuz², Müge Eylem Şengül³, Fatih Suluova⁴

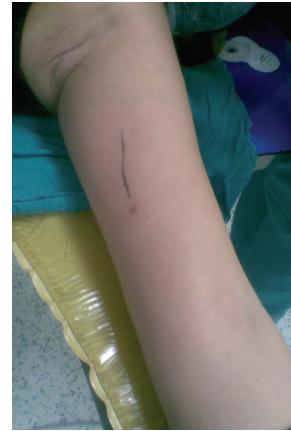
Figure 1. Impalpable implanon

orthopaedy policlinic with arm pain. The radiologist performed US again and detected the impalpable implanon (Figure 1). The anatomical position of the implant was established and the skin was then marked with a marker pen to correspond with each end of the implant in order to facilitate removal.

Implanon may be impalpable because of inadequate insertion technique (non-insertion) or deep insertion. In this case, the implanon was localized deep into muscle. Implanon is not radio-opaque but can be

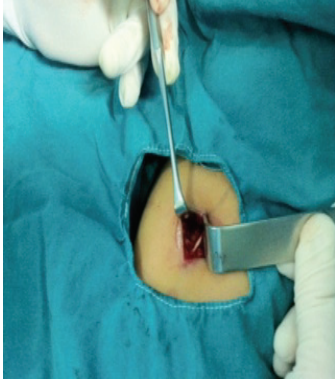
Figure 2. Incision area for implanon.

Impalpable implanon was removed under general anaesthesia. Following routine cleaning of the skin and draping of the arm with sterile cloths, a longitudinal incision was made between the previously made ultrasound skin markings. The size of the incision was between 1.5 and 2 cm (Figure 2). With careful blunt dissection the implanon was first palpated, visually identified and then removed using small mosquito forceps. The wound was reconstituted using subcutaneous absorbable sutures. The patient was discharged after six hours.

In our case, we used general anaesthesia to remove impalpable implanon because of its deep location in muscles and anxiety of the patient. We used mosquito forceps and nongrasp clamp.
